# Fractographic study of fatigue failure of a high-pressure turbine rotor blade

AIP Conf. Proc. 2503, 050081 (2022)

Research was carried out on the working blade of the high-pressure turbine of the GTK-10-4 unit, which has a crack in the feather, which has arisen during operation "Fig.1". The Customer did not provide information about the material, manufacturer, operating history and repair work for the blades transferred for research.

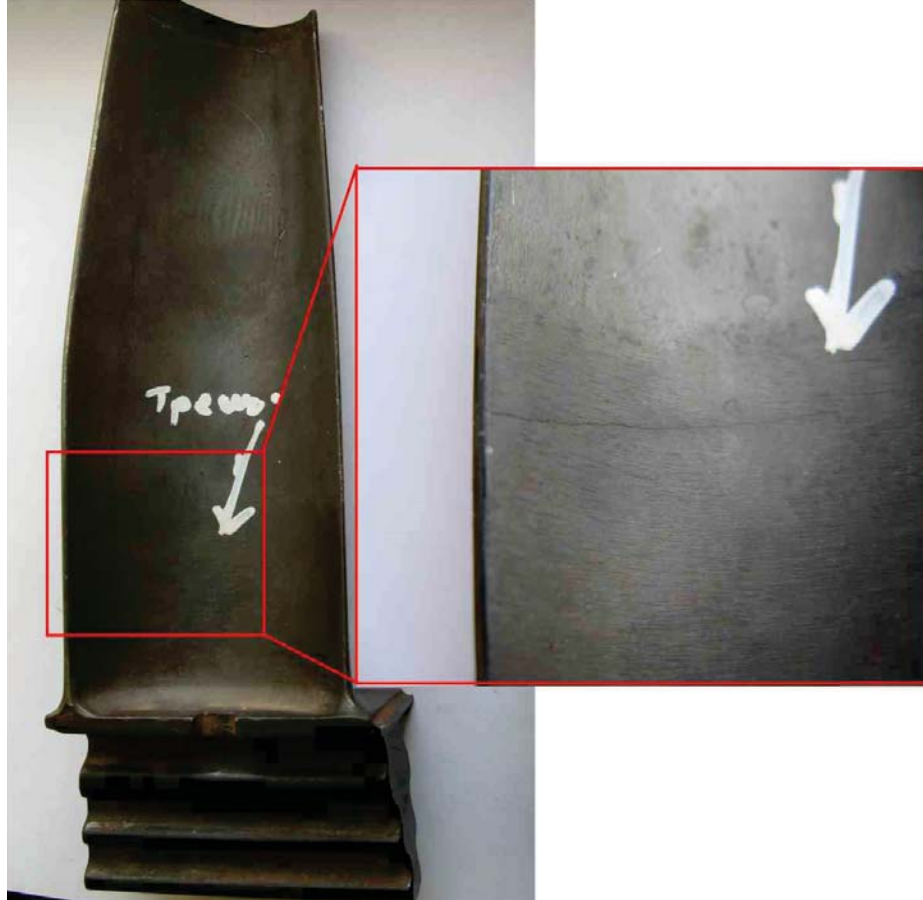
FIGURE 1. General view of a cracked working blade

The surface of the feather of the damaged scapula was examined visually and with the help of a "Citoval" stereomicroscope. On the surface of the feather from the side of the trailing edge, cracks were found, with a length of 32 mm along the trough, located at a height of 26 mm from the lock shelf, and developing towards the leading edge "Fig.1".

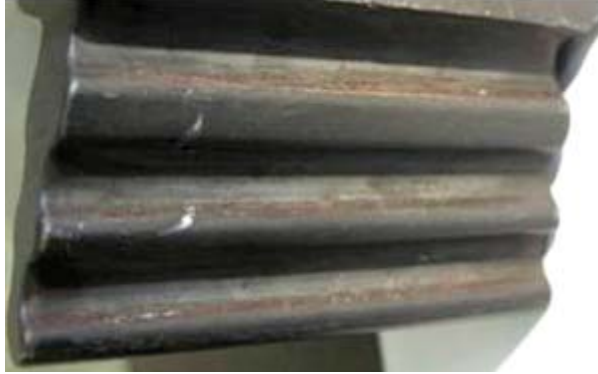
Assessment of the condition of the locking parts revealed clear traces of fretting"Fig.3", indicating a change in the amplitude of their swing, and, consequently, the likelihood of resonant oscillations.

**FIGURE 3.** Fretting wear on the blade lock.

- uneven wear of the thinning, as well as fretting on the flanges of the blade lock part, gives reason to believe that the emergency blades experienced high vibration loads[3].

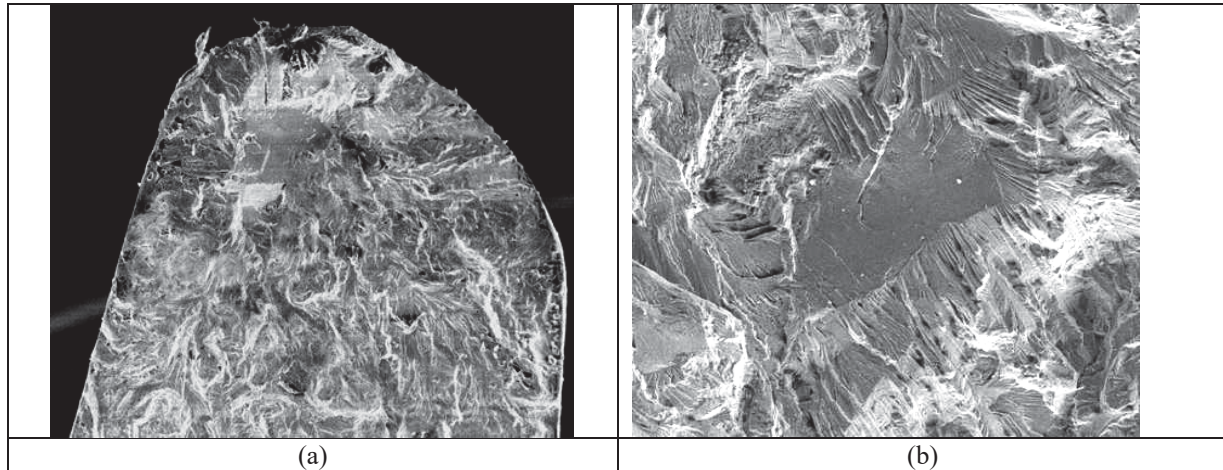
The study of the fracture relief using an optical and scanning electron microscope showed that on the fracture surface of the blade near the trailing edge there is a zone of brittle transcrystalline and intergranular fracture[4], surrounded by an intragranular fracture with a developed microrelief "Fig.4".

In the blade shoulder, the brittle fracture zone partially extends to the side surface of the airfoil from the side of the trough and has the shape of an irregular ellipse with dimensions of 550x300  $\mu\text{m}$ , elongated from the central section of the fracture surface located near the end of the trailing edge to the side surface of the blade from the side of the trough. The intragranular fracture surrounding the brittle fracture zone has signs of fatigue cracking in the form of viscous facets with grooves and fan-shaped scars, diverging from the brittle fracture zone to the outer surface of the blade from the trailing edge and towards the leading edge. This nature of the fracture makes it possible to determine the seat of destruction of the blade airfoil as a zone of brittle fracture near the end of the trailing edge. The brittle fracture zone is predominantly intragranular facets, misoriented relative to each other so that the fracture surface of this section does not lie in the plane of fatigue growth of the main crack, that is, the formation of a focus is not associated with the stress state pattern from the action of working loads. The shape of the brittle fracture area (focus) in the form of a conditional ellipse with the ratio of length over the blade surface to depth as 1 to 2 shows

that the formation of the center was, apparently, subsurface with an exit to the outer surface from the side of the trough. After that, the destruction developed by the growth of cracks by the fatigue mechanism.

**FIGURE 4.** View of the fracture surface of the blade airfoil from the side of the trailing edge.  
a – crack growth topography, brittle intergranular fracture;  
b - topography of the fracture of the blade airfoil at the stage of fatigue crack growth.

3. The probable reason for the formation of a brittle crack in the end face of the trailing edge can be considered the fact that thermal repairs were carried out on the blade airfoil. A characteristic indicator of thermal repair work is the presence of solidified melt drops on the fracture surface in the brittle fracture zone at the trailing edge of the
