Stability analysis of pit slopes in Zapadno-Ozerny quarry to ensure mine safety

> **Abstract.** The article discusses the design parameters of open pit slopes and the approach to calculating the stability of open pit slopes. The main deformations of slopes of open pits are considered. An assessment of the influence of the stress-strain state of quarry slopes on their stability is made. On the example of an open pit at the Zapadno-Ozernoye field, the assessment of stability under the actual stress-strain state of the site was performed. Recommendations to determine the new boundaries of the open pit, in which the section of the South Eastern slope of the open pit will be stable are given.

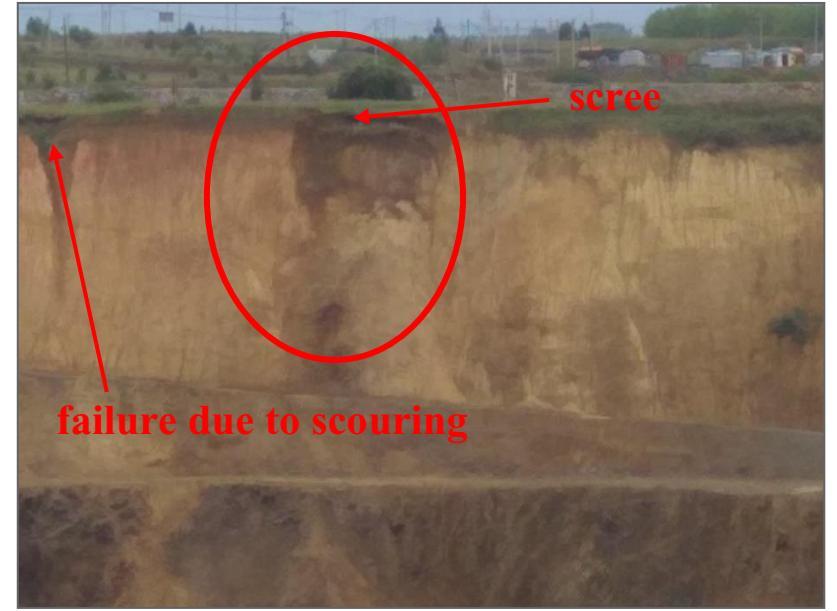
The least stable areas in the quarry are upper levels, where smooth deformations of slope fronts, composed of loose clayey sediments and intensely weathered rocks have taken place for long periods of time. In these areas, deformation processes are recorded in the form of screes and failures due to scouring. These deformations increase in size over time and lead to the destruction of the open pit bench and the adjacent pit wall surface. One of these areas is the eastern side of the open pit (Fig.1).

Fig. 1. Upper quarry face deformation in August 2019.

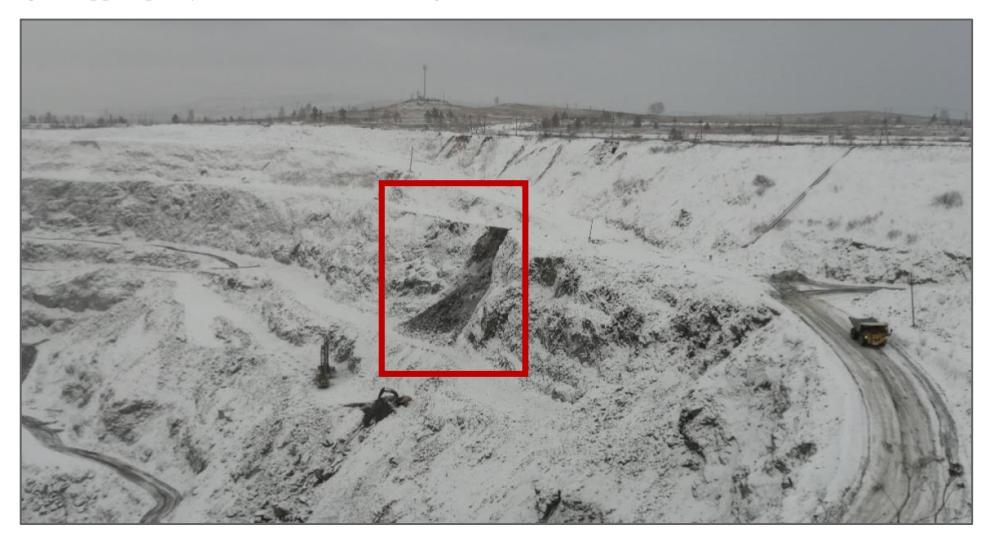
The middle and lower groups of open pit benches are composed of fractured intensely weathered andesite-dacites. In addition, there are local deformations in the form of screes observed on these levels due to the weathering of rocks in the near-slope part. In October 2019, a rock mass fell out on the eastern side at elevations of $470 \div 420$ m. The collapse was recorded on the open pit bench above which the transport ramp is located (Fig. 2).

Fig. 2. Upper bench deformation at elevations of 470-420 m in October 2019.

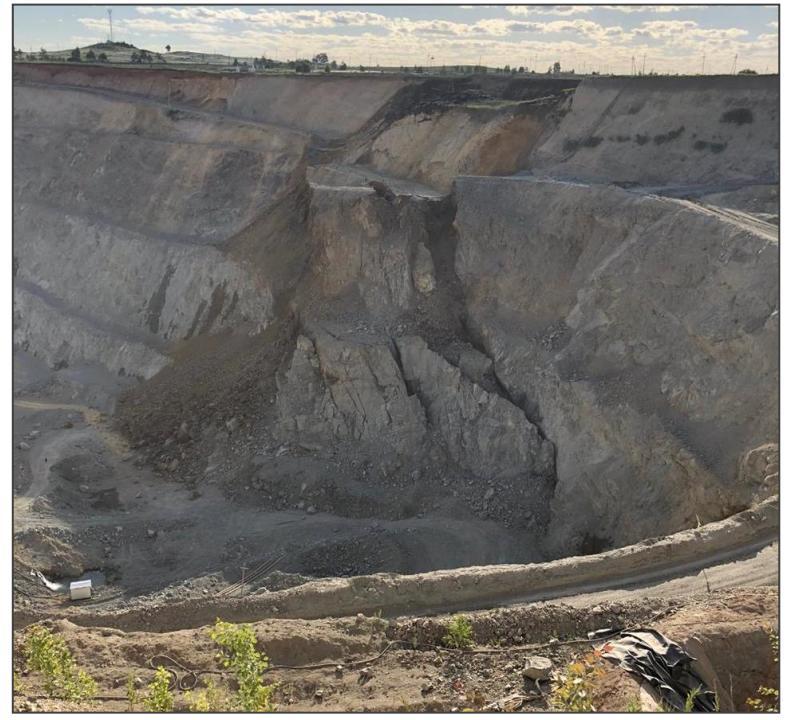
In April 2020, deformations were also recorded in the form of local collapse of the open pit bench at elevations $497 \div 485$ m and deformations at elevation 478.4 m (transport ramp) in the form of subsidence with the following crack dimensions: the length is 8.0 m and the width is 0.1-0.15 m. At the beginning of June 2020, the mine surveying service of the enterprise recorded the collapse of a rock mass with a total volume of 120.758 m³ with its displacement towards the mined-out area on the southeastern side of the open pit of Zapadno-

Ozerny deposit (Fig. 3). According to the certificate of the collapse, the dimensions of the deformation were as follows: the length along the front is 140 m and the development depth is 23 m.

Fig. 3. Southeastern bench deformation at elevations of 504-400 m.

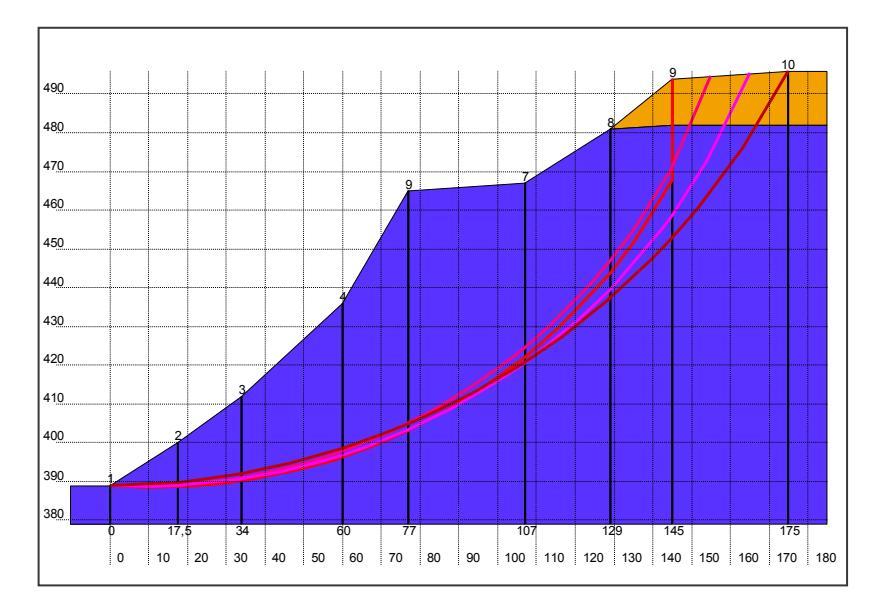
Figure 4 shows the calculated sliding surfaces for stability rating of the actual state of the deformation area. The obtained data on the values of the safety margin coefficient were summarized in Table 2.

The calculation results showed a weak stability of the slopes resulting in the deformation development and the instability of the enterprise performance. Further open pit mining is possible only when correcting the southeastern open pit limits, thus ensuring its long-term stability.

One of the main reasons for the deformation occurrence in the open pit of Zapadno-Ozerny deposit is the overestimated design angles of the benches, which do not correspond to the actual physical and mechanical characteristics of the rocks composing these open pit benches. The staff of Uralmekhanobr Institute rebuilt the recommended (new) open pit limits to ensure long-term stability of the open pit wall.

Fig. 4. Calculated strip pits. Stability rating of the actual state of the deformation area.

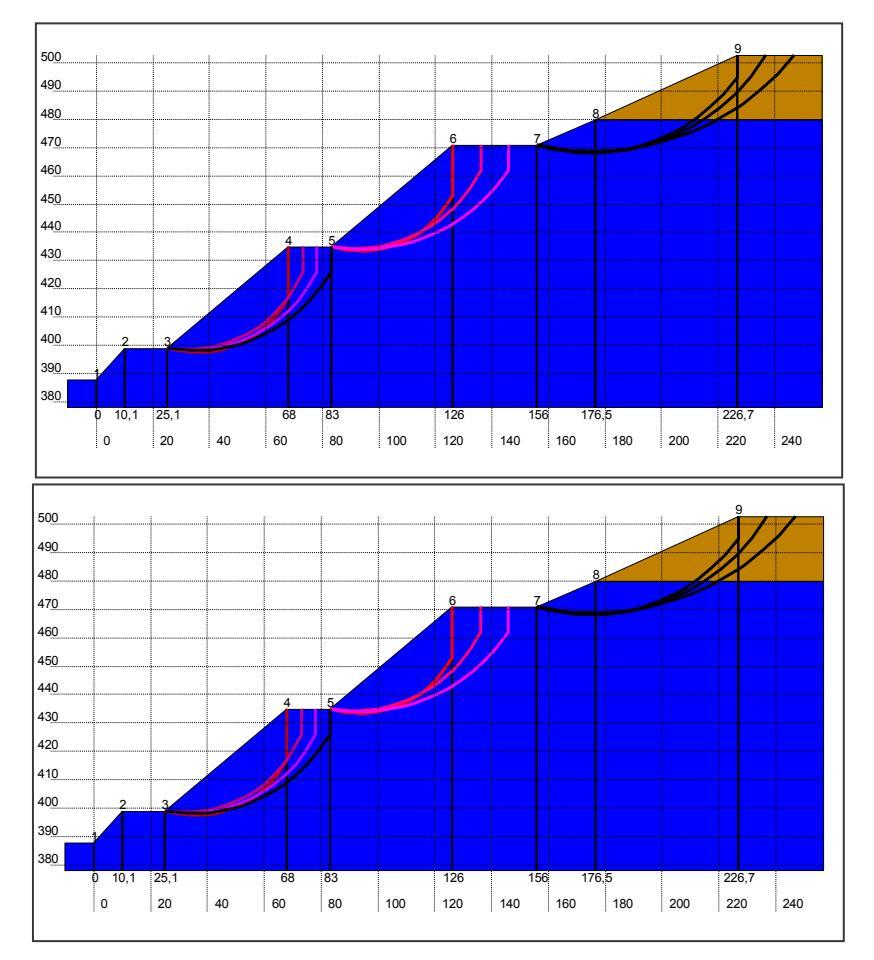
The stability rating was carried out along the new open pit limits in the software package Slope. The design sliding surfaces are shown in Figure 5. The stability rating of the recommended open pit limits is presented in Table 3.

Fig. 5. Calculated strip pits. Stability rating of recommended open pit limits.

Based on the calculations performed, Uchaly Mining and Metallurgical Combine was recommended to reduce the slope angle of the upper part of the eastern open pit wall at elevations $508 \div 479$ m to 24° in the area under consideration and reduce the slope angle at elevations $477 \div 438$ m to 40° . With these parameters, the pit wall will be in a steady state [8] that will ensure the safe development of the field.

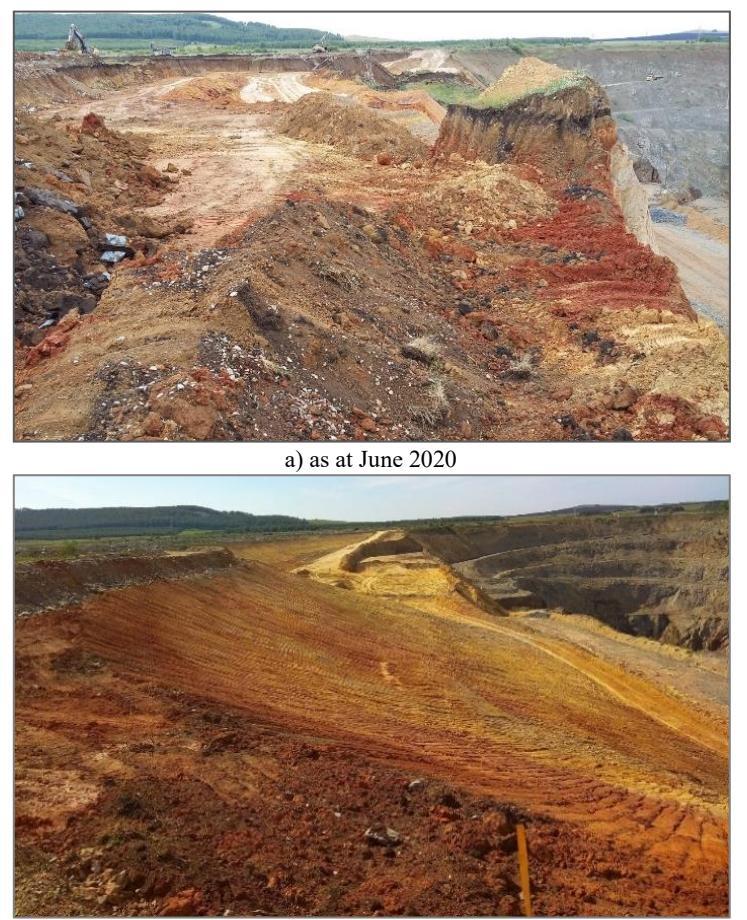
b) as at August 2020

Currently, the enterprise is working on the excavation of the upper levels to give the slope the recommended parameters (Fig. 6).
